## Chapter 39 (Video Clip 39) - Engine Work

***VW Restore #2 is Now Complete***  
*(All other Work will be considered as normal maintenance)*

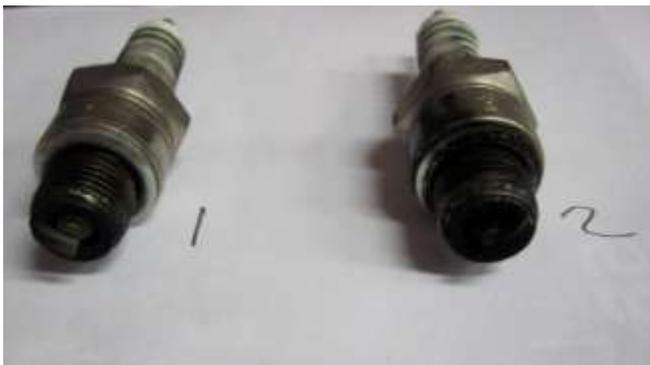
1629. The spark plugs were removed and kept in order. By inspection they did not look very clean even though they were in good condition.

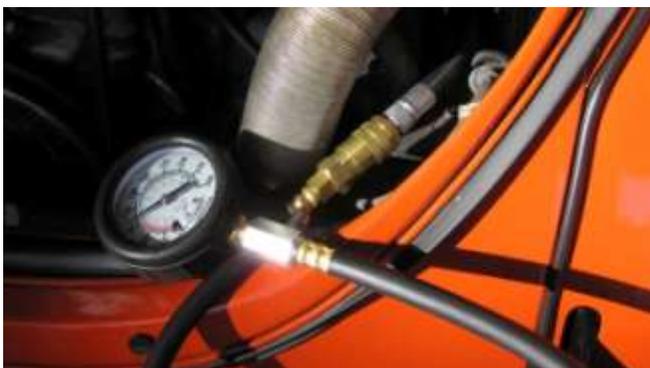
1630. A compression check was made and the results were not very good. One cylinder was reading 60. With this low reading I pondered about it for a few days and then I took the car to German Car Service in west Mobile. Tommy Humes who installed the brakes last August, said they needed adjusting after a few miles.

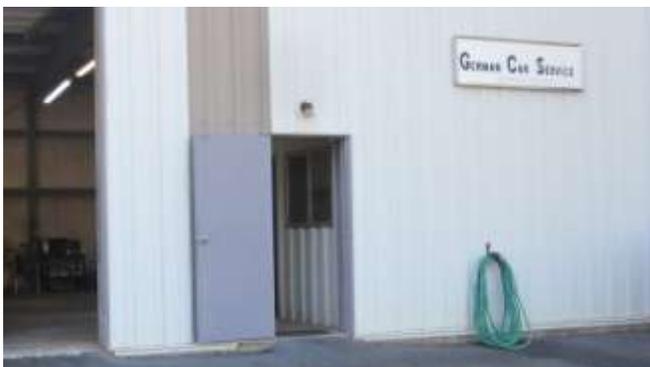
1631. Tommy checked the brakes and adjusted the valves and performed a full compression check. The compression reading was 105 lbs. for cylinder #1; 130lbs for cylinder #2; 125lbs. for cylinder #3 and 40lbs. for cylinder #4. We knew something was wrong with cylinder #4. Tommy rechecked the compression for the #4 cylinder and found that the valve sleeve was gone and was very loose. If broken it could take out the entire engine.

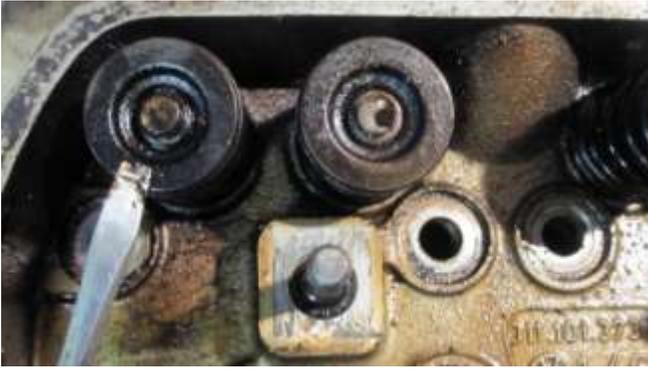
1632. A screwdriver could easily move the valve around. Tommy called to get prices and no single port heads could be found so we decided to go ahead and replace both heads with new duel port heads. The manifold and some of the tin would need to be replace to match the duel port head, but Tommy had some used pieces. Tommy advised that he could start on replacing the heads after lunch. I called Wilma to bring me my cameras since I would stay and take pictures and help clean up and paint the tin.

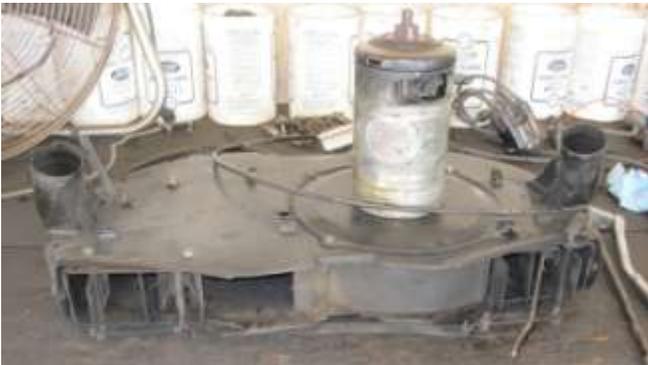
1638. Engine shroud and generator shown removed. Since the thermostat was not working, the adjustment flaps were removed.

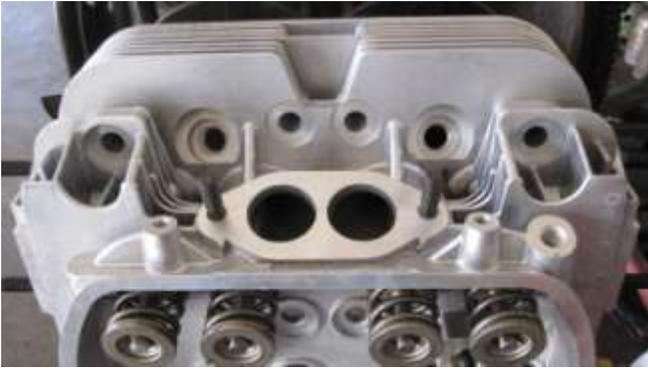
1645. The dual port heads arrived and Tommy set them in place, now this piece is no longer stock.

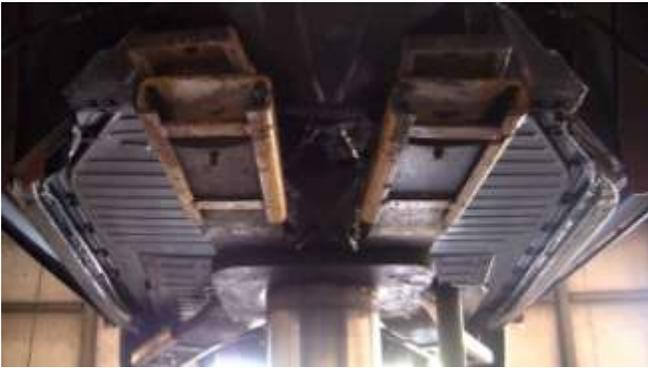
1653. A view of pans from underneath. I went ahead and sprayed the pan with a couple of cans of spray on truck bed liner material, since the car bottom was accessible.

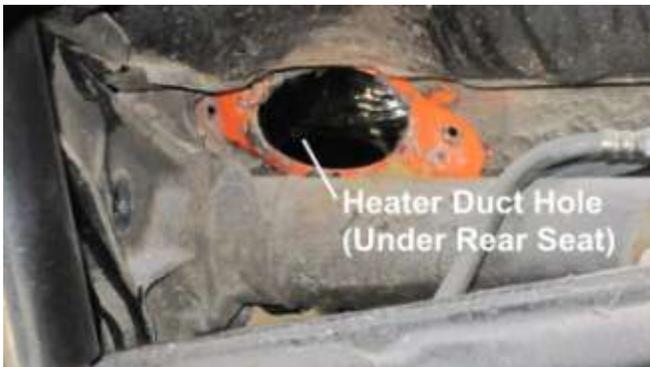
1666. The heater duct hole that is under the rear seat that I covered up with insulation (Quick Roof). In Mobile there is not much need for a heater when I would be driving this car. Note: Later, I sprayed this area with undercoating.

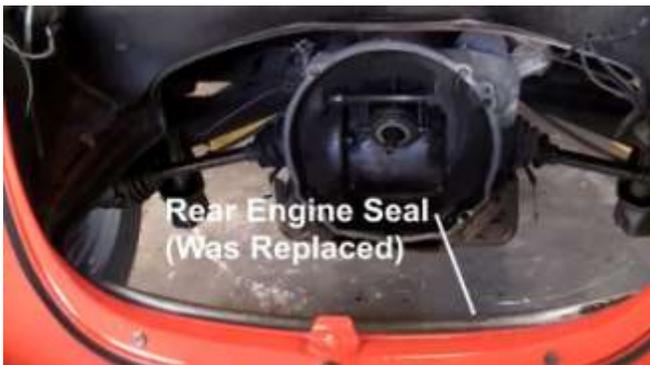
1667. The rear engine seal. Tommy replaced it with a new one.

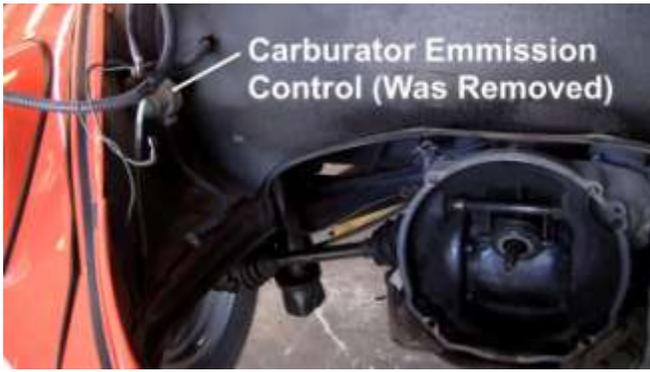
1668. Later, Tommy removed the carburetor emission control valve since it was no longer being used.

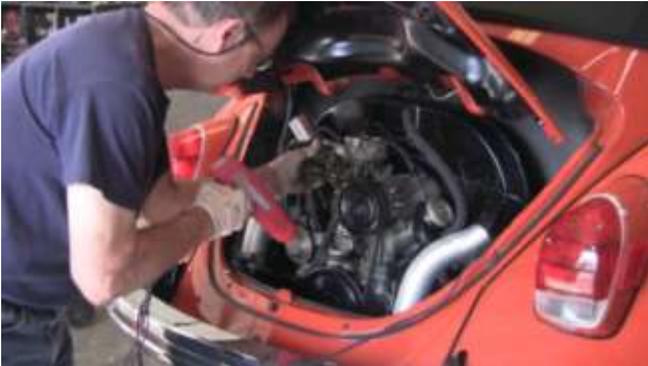
1689. Set the Timing 0 degrees top dead center. Tommy asked that I bring the car back in after 500 miles to have valves adjusted and the head bolts re-torque.
