Chapter 25 - Wheel Well & Fender Treatment (Video Clip 25)

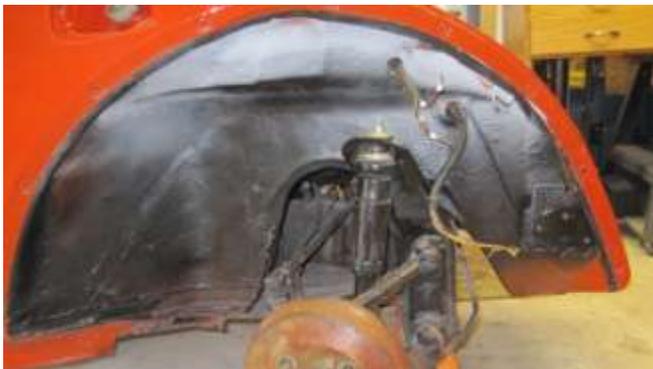
941. Previously the fender wells were painted with one coat of POR15 and one coat of Rust-Oleum truck bed liner material but prior to adding the fenders I painted another coat. After the fenders are installed I will spray on a another coat to protect the bolt areas.

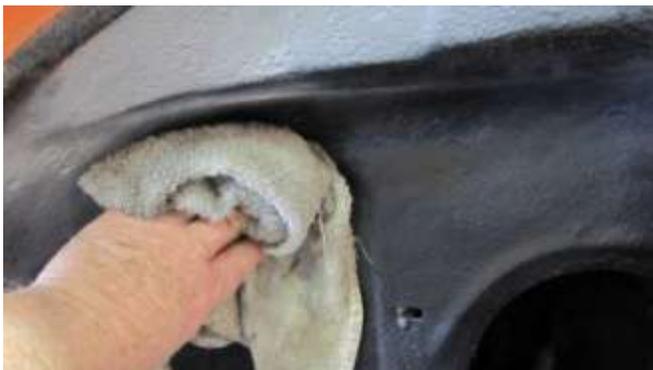
942. First, wipe the fender well down with a damp rag and let air dry.

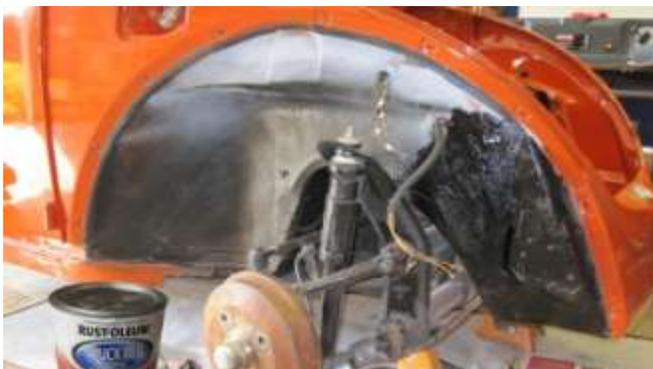
943. Begin painting the Rust-Oleum truck bed liner material, with a brush.

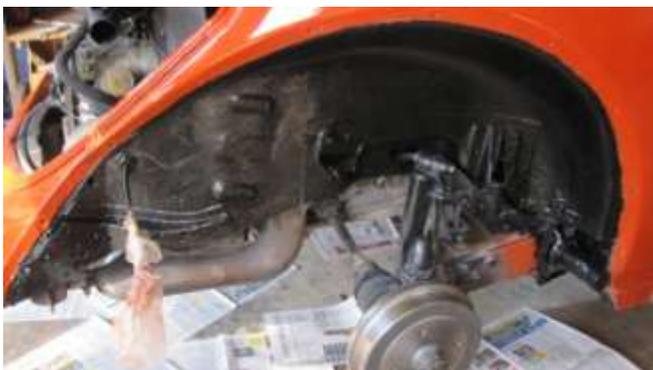
944. The rear fender well with Rust-Oleum coat completed.

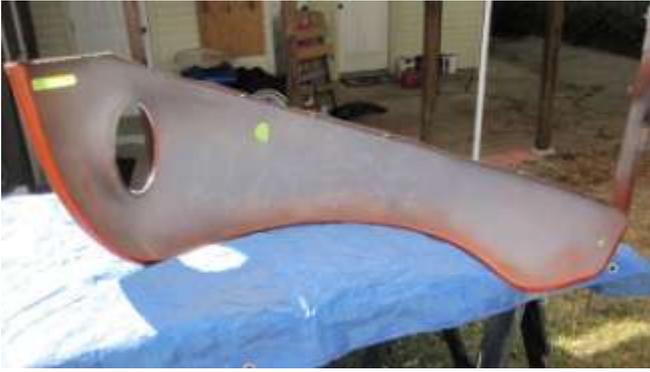
945. Also coat the underside of the fenders with the Rust-Oleum truck bed liner material.

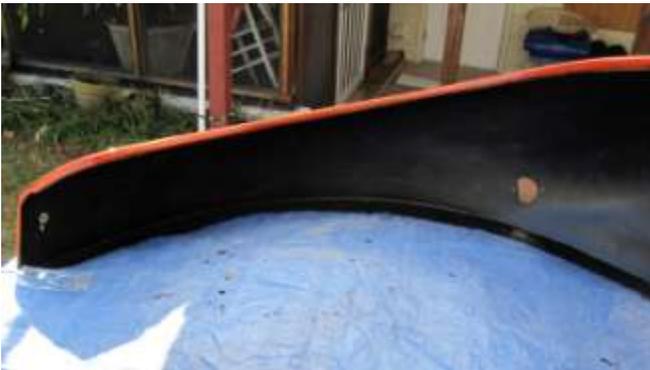
946. Fender shown with Rust-Oleum truck bed liner material completed.

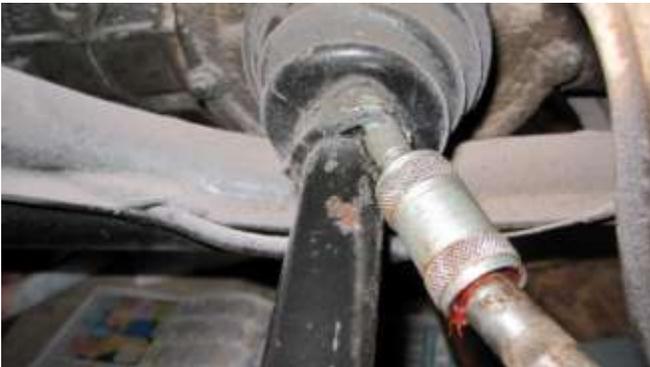
947. Prior to painting the wheel hubs, my helper, Vic Diabin wanted to grease the CV joint. He had a gizmo that you put on a grease gun that shoots grease behind the rubber boot. Then he had a tool that re-clamped the band on the rubber boot.

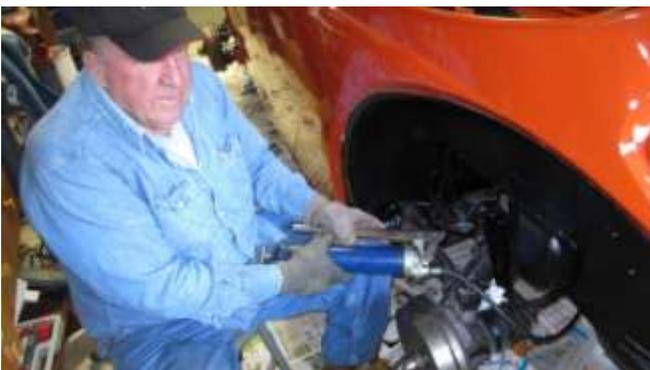
948. Vic greasing the CV Joints.

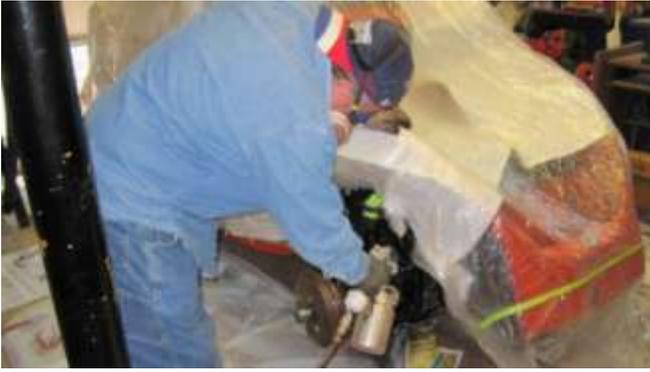
949. Vic painting the wheel hubs.

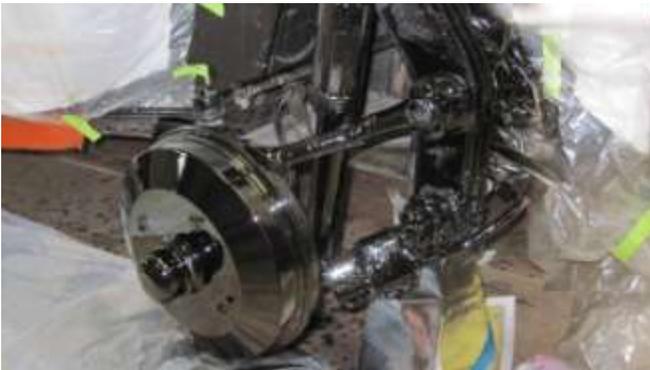
950. A view of the front wheel hub completed.

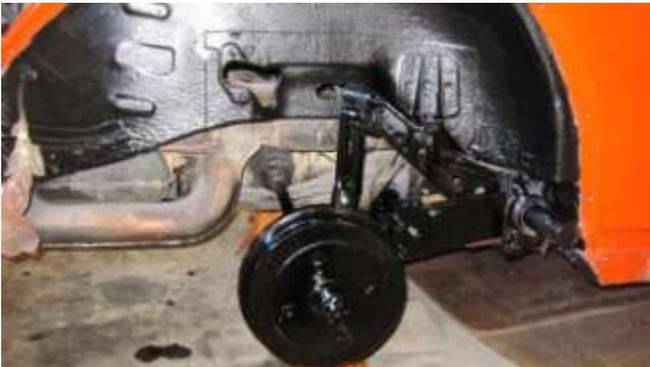
951. A view of the rear wheel hub completed.

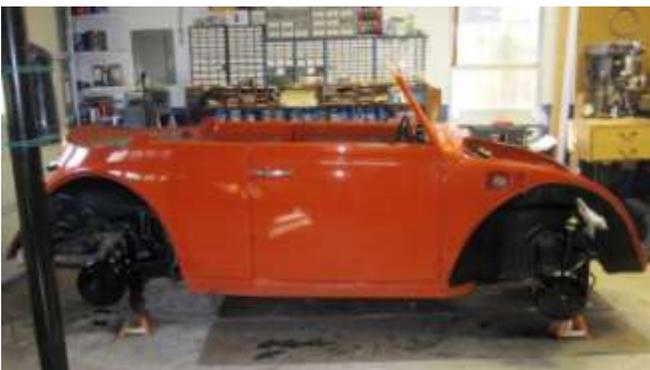
952. A view of the wheel hubs completed.

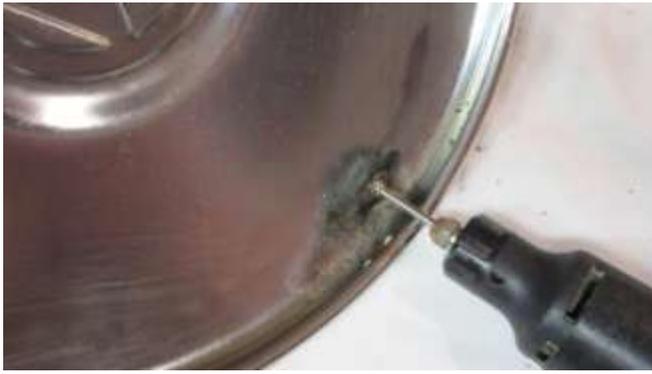
953. Clean up both sides of the hub caps. Using a small wire brush to remove any rust deposits on the underside of the hubcaps. Wash with soapy water and air dry.

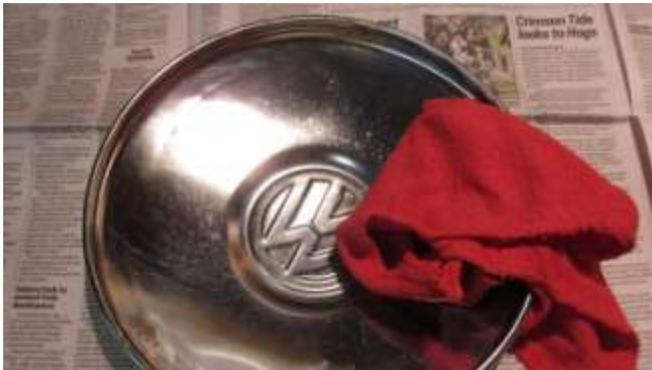
954. Wipe the dust off the outside of the hubcaps.

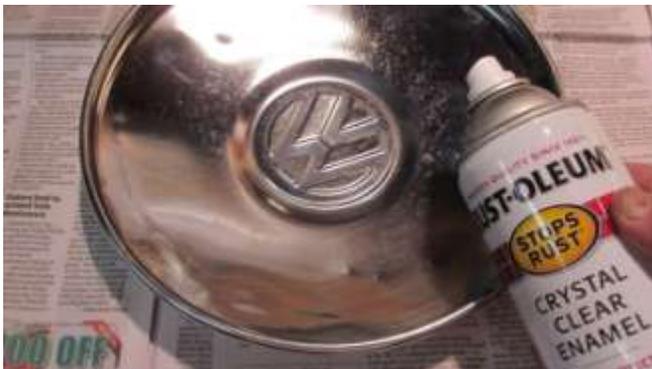
955. Paint the inside of the hubcaps with Rust-Oleum crystal clear enamel paint.

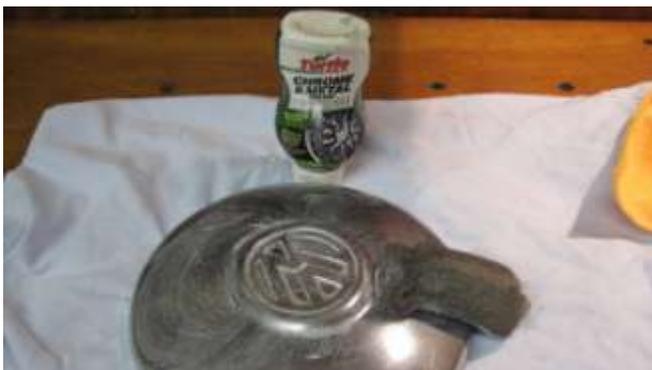
956. Clean the outside of hubcaps with Turtle Wax Chrome and Metal Polish and a fine grain steel wool.

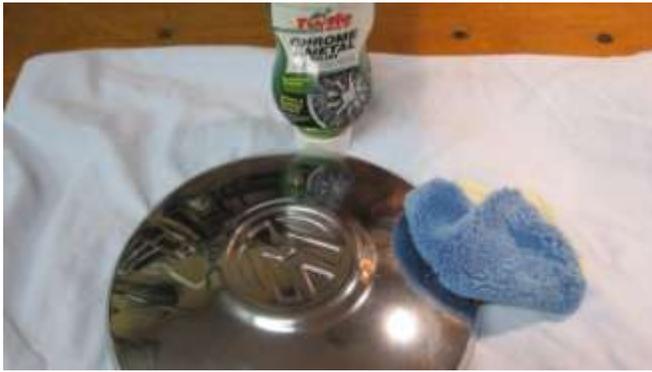
957. Polish the outside of the hubcaps with Turtle Wax Chrome and Metal Polish and a polishing rag.

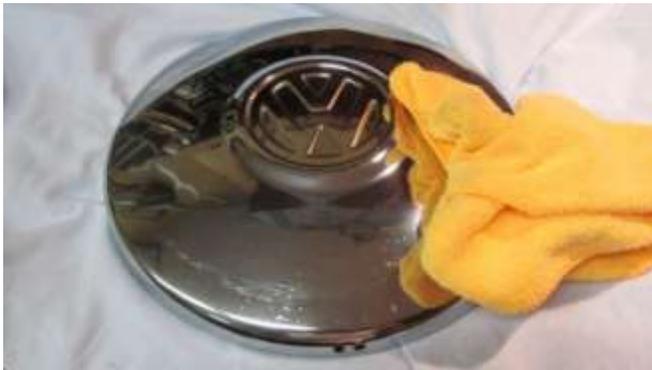
958. Polish the outside of hubcaps with more Turtle Wax Chrome and Metal Polish and wipe down with a micro fiber cloth.

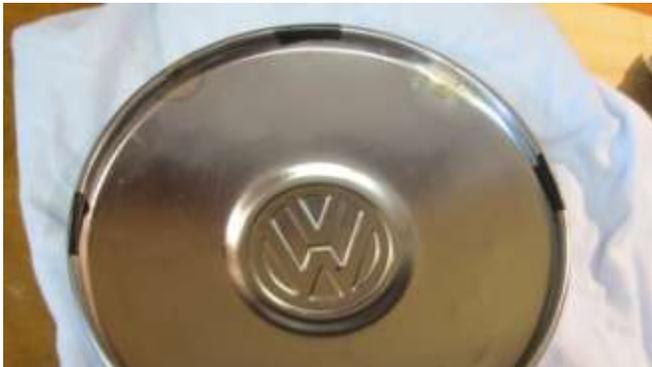
959. Put electrical tape on the inside of the hubcaps rim to minimize marring the new painted wheels on the four clip on ribs.

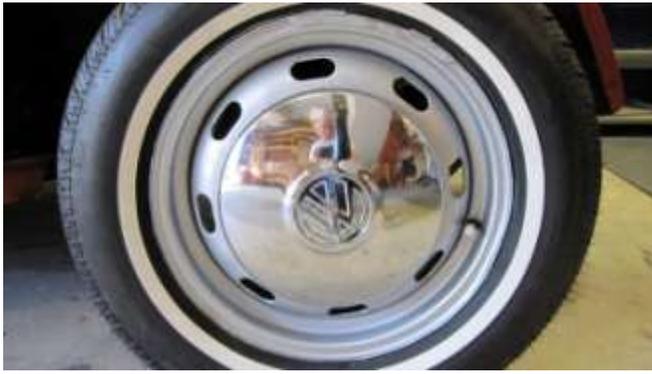
961. The wheels were taken to a local tire store and balanced and then installed on the car and the hubcap placed on new painted wheels.
