## Chapter 33 - Light Installation and Interior Painting (Video Clip 33)

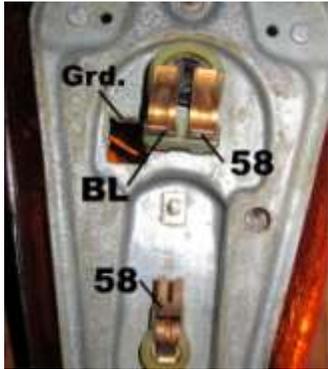
### Left Parking Light

1214. Push the wires through the new parking light rubber seal. Separate the wires, number, and connect to parking light assembly as shown.

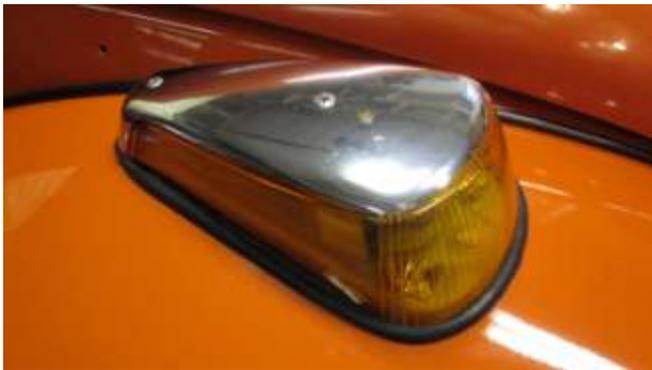
1215. Slide on the parking light assembly and connect the two M5 nuts underneath the fender. Use a 8mm socket to tighten the nuts. Repeat for the other parking light assembly.

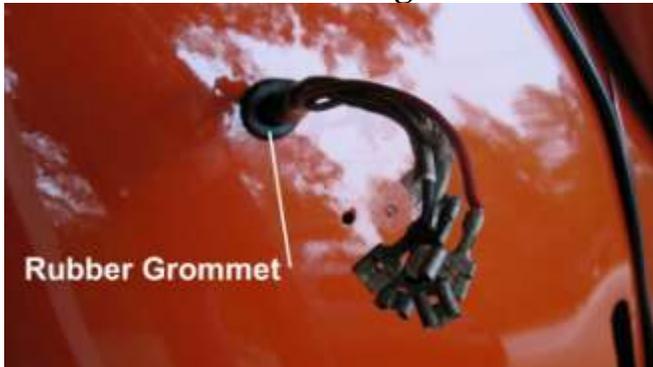
1216. Insert a new rubber Grommet in the fender hole and push the wires through it.

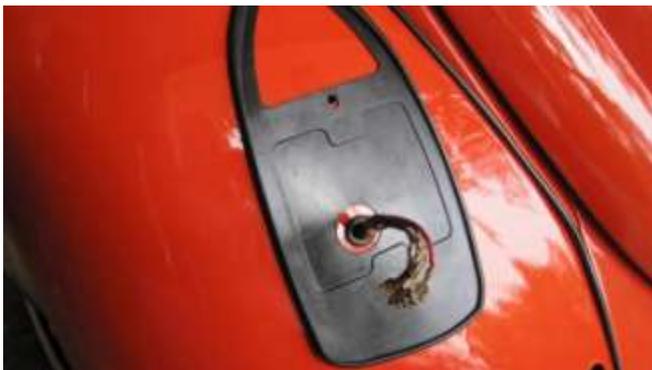
1217. Insert a new rubber seal and push the wires through, as shown.

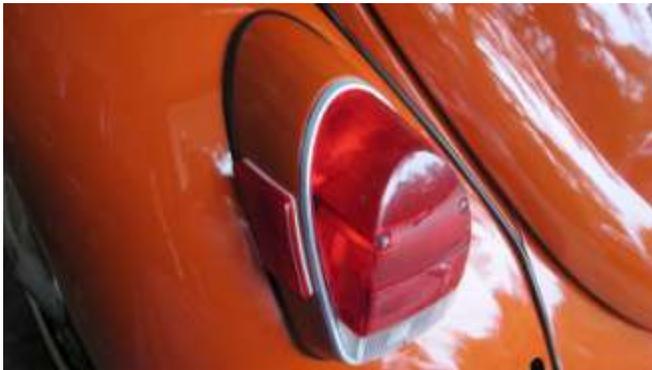
1219. Connect the two M5 nuts underneath the fender and use a 8mm socket to tighten the nuts. Repeat for the other tail light assembly.

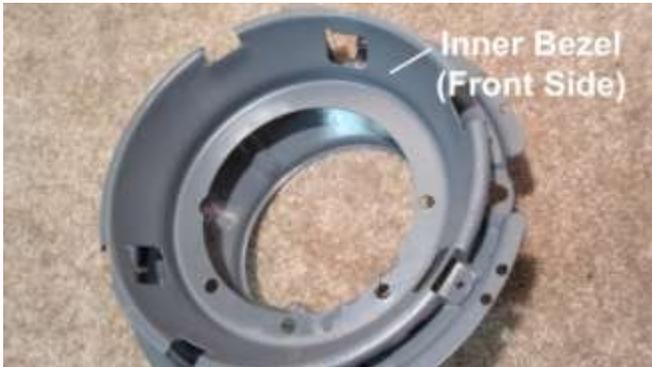
1224. Front of headlight inner bezel shown.

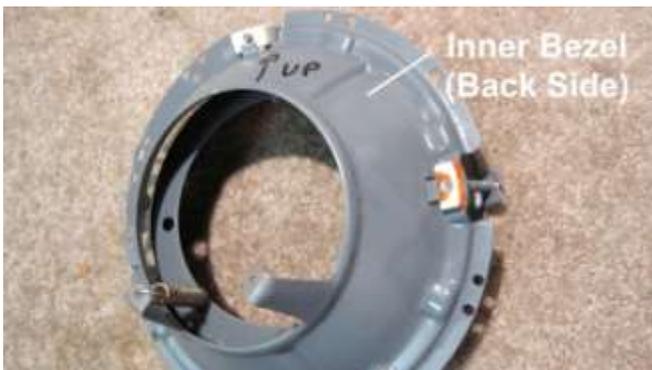
1225. Rear of headlight inner bezel shown.

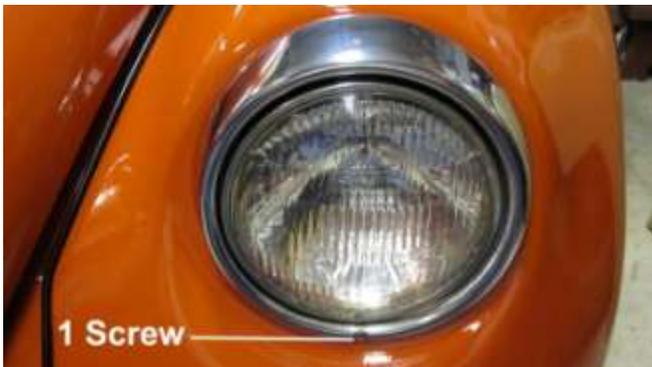
1228. Install the headlight outer ring with single screw, as shown.

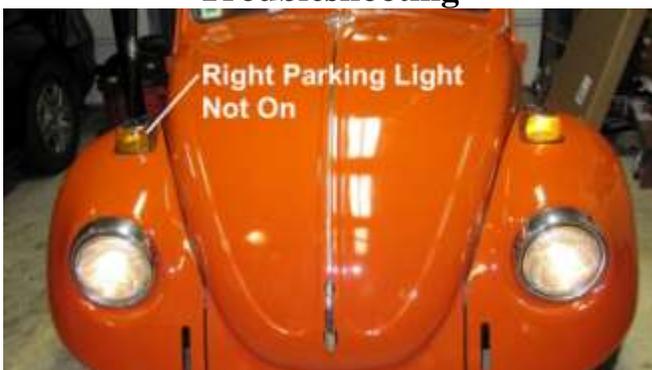
1229. Next, turn on the lights. As you can see the right parking light is not working.

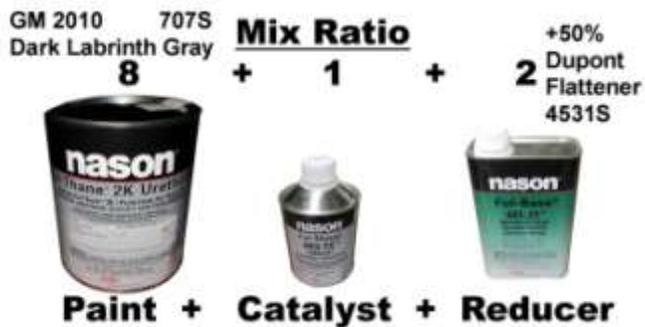
1249. I used the same type of Dupont Urethane used to paint the car. The paint store could not determine the proper mix for the original color seat color (L43 grey-black) so I used my pocket door to pick the closest paint I could find which was a General Motors 2008, 2009 & 2010 707S dark labrinth gray. As shown, I added 50% of Dupont flattener to make it more of a satin finish. In hind sight the finish still had too much gloss, so 75% would be better.

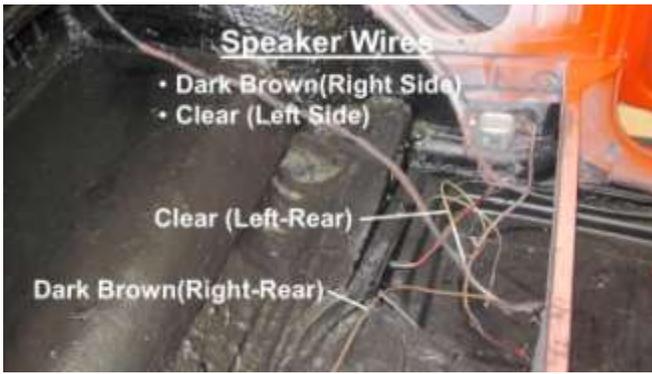
1266. Replace the speaker wires in the conduit. Dark brown wires were used for the right side of the car and clear wires were used for the left side of the car.
