## Chapter 13 - Hood Repair (Video Clip 13)

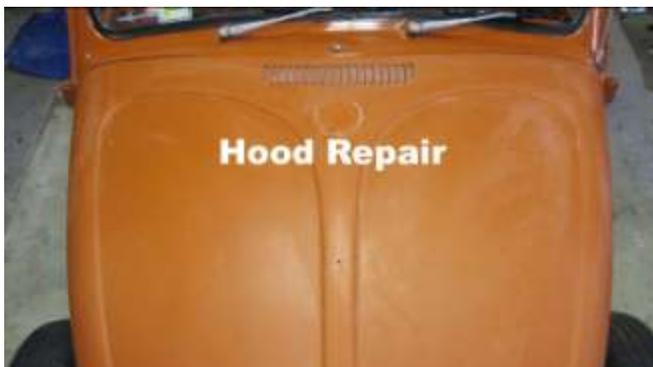
436. Wipe hood down with acetone.

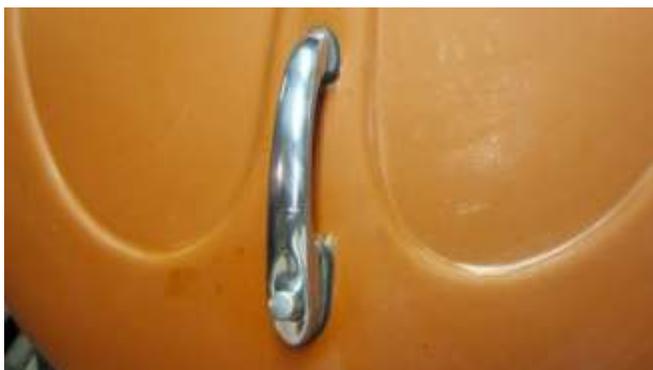
437. Front side of hood latch.

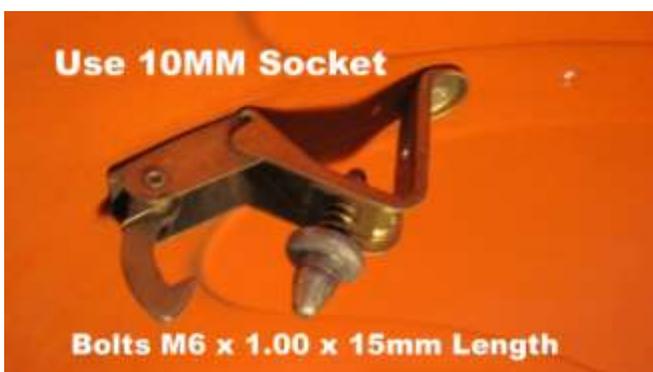
438. Back side of hood latch. With a 10MM socket remove the hood latch. Bolts are M6 x 1.00 x 15mm long. Clean the latch with WD-40 and store in plastic bag.

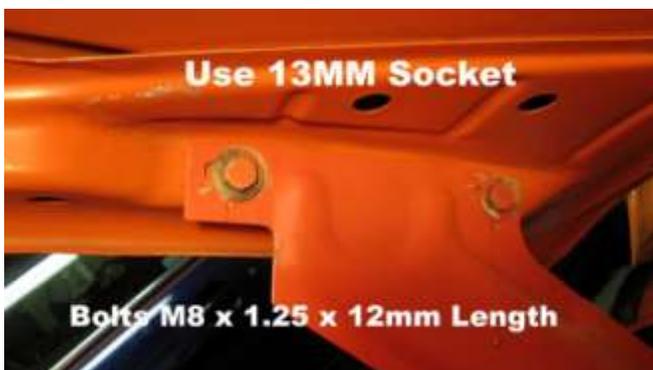
439. With a 13MM socket remove the 4 hood bolts (2 on each side). Bolts are M8 x 1.25 x 12mm long.

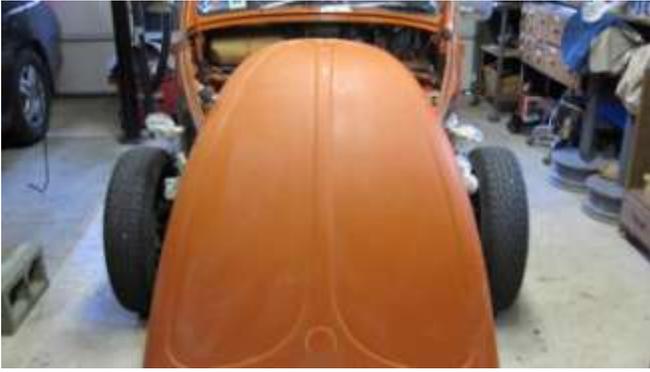
440. Hood removed. Check for dents to be hammered out.

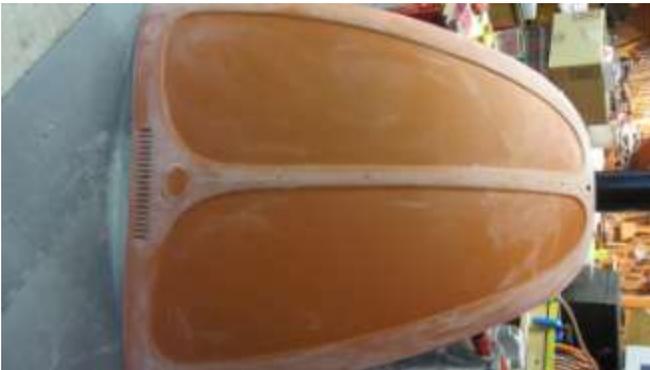
441. Sand with 120 grit sandpaper dry then 220 grit sandpaper wet.

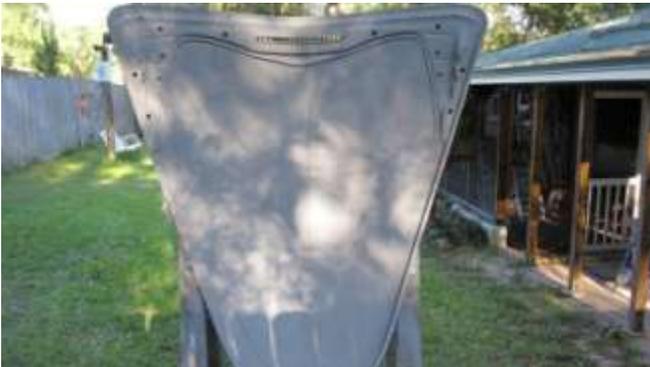
442. The same procedures shown in detail in the fender section was used for patching dents, priming and painting the hood. After sanding each time I washed the hood down with water, let dry then wiped the hood down with wax and grease remover with one rag and then dried with another dry rag. Then mixed paint for painting the back side.

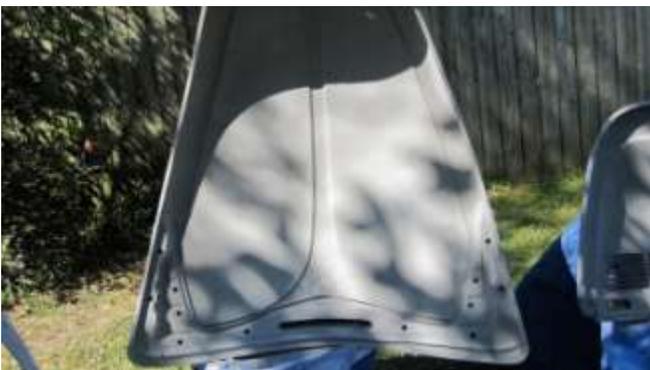
443. Back side of hood after second coat of prime paint. After sanding and prepping a third coat of prime was painted on the back side.

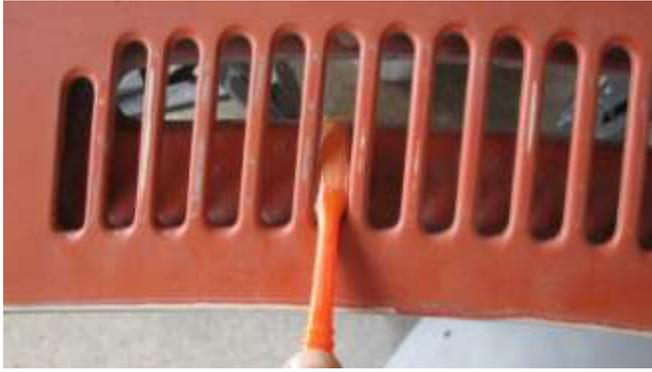
444. Sand the front side of the hood and make sure the area between the louvers are sanded well and the frame area under the louvers are cleaned. I used a narrowed tooth brush to clean this area.

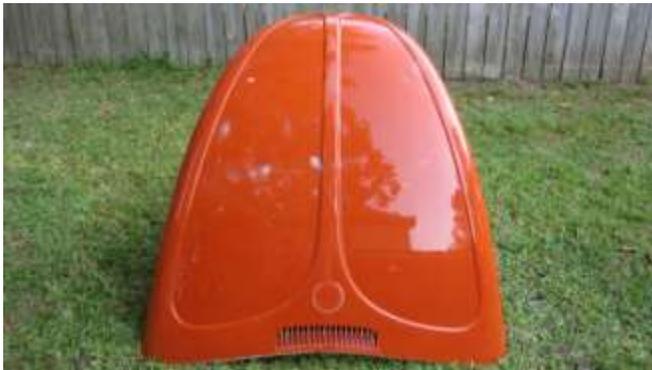
445. Wash the hood, let dry then wiped the hood with wax and grease remover with one rag and then dry with another dry rag. Then mixed paint for painting the front side.

I painted the front side and was not happy with the results.

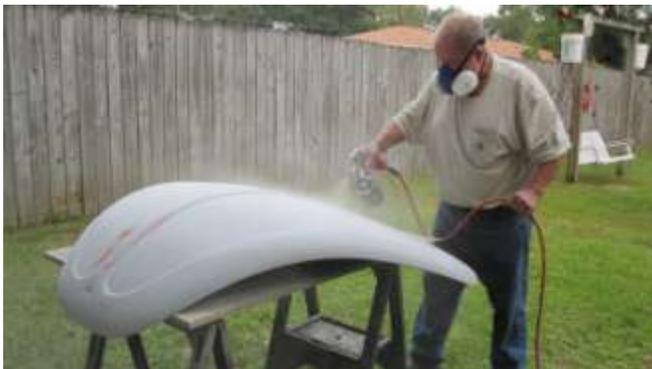
446. After all my practice work I seemed to have gotten worst on the first coat of paint on the front side of the deck lid and hood, so I called in my paint consultant, Vic Diabin to give me a refresher class on painting. It appeared that I had:

- Spray gun not adjusted properly
- Paint to thick
- Held gun to far away from surface
- I moved the gun to fast

Vic, painted two coats on the front side.

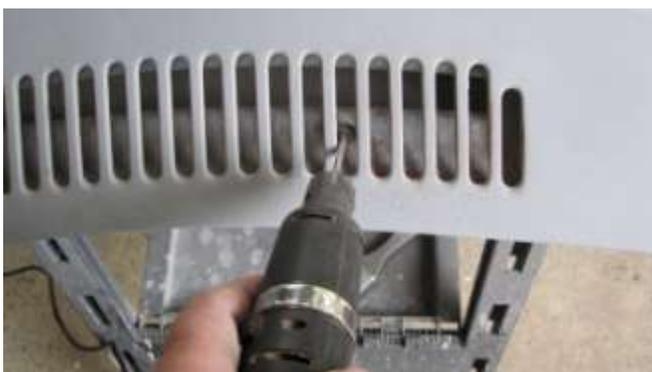
447. I used all kinds of methods to clean or sand the inside of the air vent area as shown. A total of 4 Coats of prime was painted on the back side and 6 coats of prime on the front side. The hood was then stored awaiting final rubdown and painting.

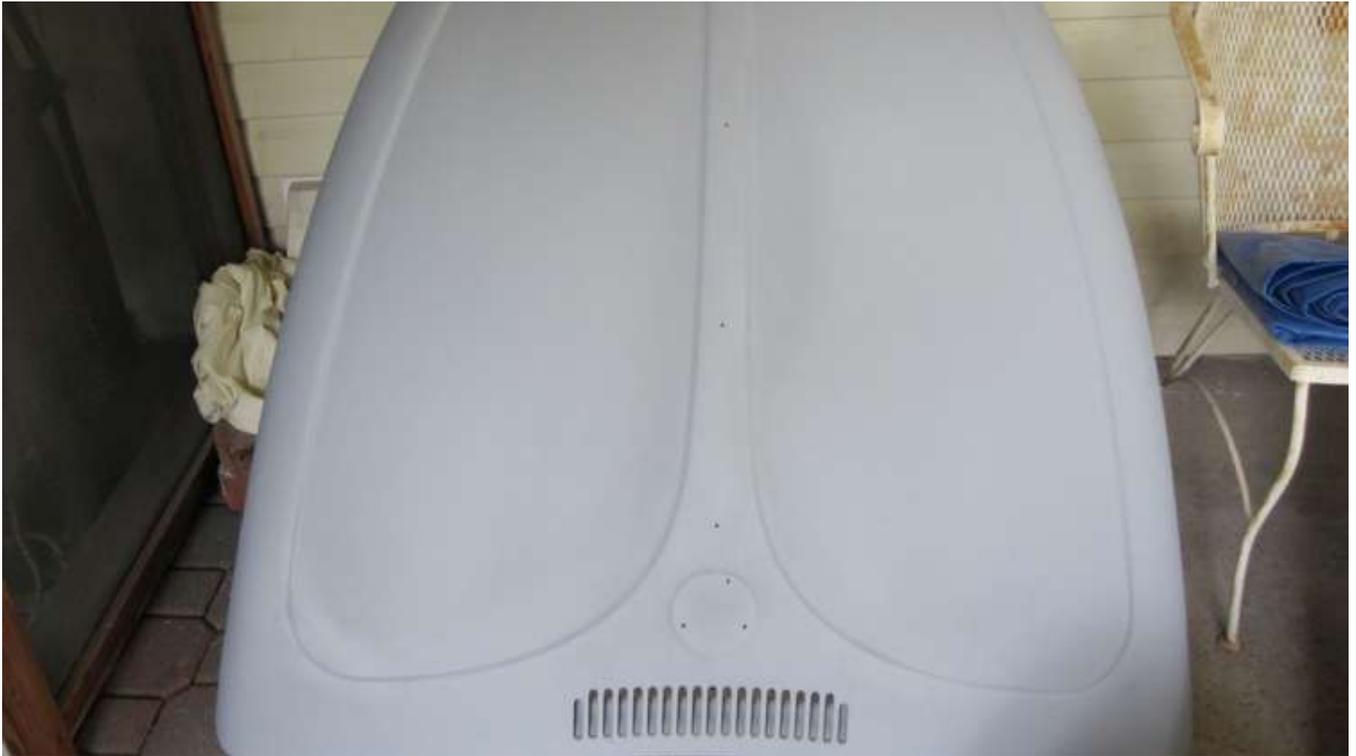
448. Front side of hood after four coats of prime.
